**DEPARTMENT OF TRANSPORTATION****DIVISION OF ENGINEERING SERVICES**

Contract #: 04-0120F4Cty: SF/ALA Rte: 80 PM: 13.2/13.9File #: 1.28**WELDING INSPECTION REPORT****Resident Engineer:** Siegenthaler, Peter**Address:** 333 Burma Road**City:** Oakland, CA 94607**Report No:** WIR-017703**Date Inspected:** 28-Oct-2010**Project Name:** SAS Superstructure**OSM Arrival Time:** 1000**Prime Contractor:** American Bridge/Fluor Enterprises, a JV**OSM Departure Time:** 1830**Contractor:** American Bridge/Fluor Enterprises, a JV**Location:** Job Site

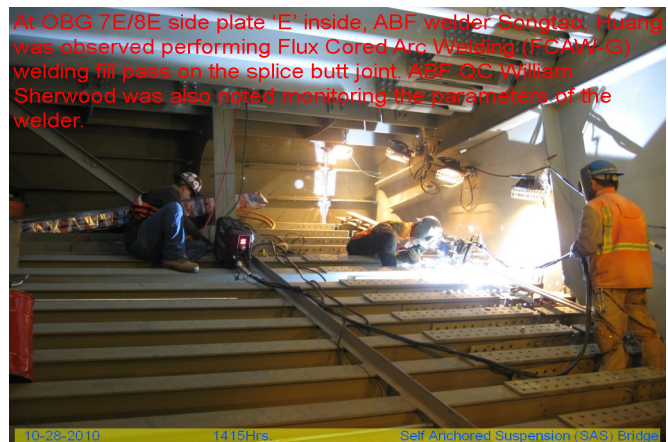
At OBG 7E/8E side plate 'E' (1000mm to 4300mm) inside, QA randomly observed ABF/JV qualified welder Sungtao, Huang ID # 3794 continuing to perform CJP groove (splice) welding fill pass on the splice butt joint. The welder was observed perform automatic welding in the 3G (vertical) position utilizing a dual shield Flux Cored Arc Welding (FCAW-G) with E71T-1M, 1/16" diameter wire electrode and implementing Caltrans approved Welding Procedure Specification (WPS) ABF-WPS-D15-3042A-1. The joint being welded has a single V-groove butt joint with backing bar. The splice joint was preheated and maintained to greater than 150 degrees Fahrenheit using Miller Proheat 35 Induction Heating System heater blankets located at the opposite side of the plate prior/during welding. During welding, ABF Quality Control (QC) William Sherwood was noted monitoring the

welding parameters of the welder. At the end of the shift, welding of the fill passes on the splice butt joint was not completed and should continue tomorrow.

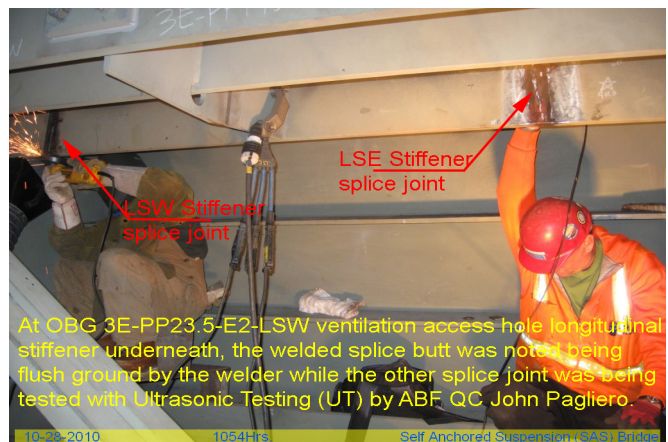
At OBG 3E-PP23.5-E2-LSE longitudinal stiffener underneath the ventilation access hole infill plate inside, QA noted the splice butt joint was completely welded from both sides of the joint. ABF welder Hua Qiang Hwang ID #2930 was observed flush grinding the weld cover of the butt joint. While this welder was flush grinding the weld cover at this location, another ABF welder Xiao Jian Wan was noted preparing welding machine to perform weld battering on the bevel of the next longitudinal splice butt joints OBG 5E/6E LS6 and LS5. At the end of the shift, both welders were still performing their respective tasks and should continue tomorrow.
